# Delamination in Sheet-fed Offset Printing

**THE DEVIL IS IN THE DETAILS, AS THEY SAY //** This is the case for delamination as well – an error referring to the separation of layers in the printing stock, both with paper as well as cardboards.

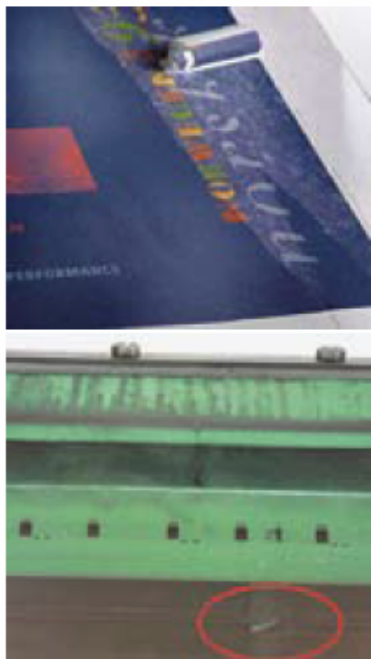
*Layers can roll up in the pile up to 15 times during various motion processes. This leads to rolled-up strips on the printing stock. If these are run through the printing press, the printing blankets inevitably get damaged and in extreme cases, other units can also be damaged.*
